# **RAINWATER HARVESTING AT VIDYA PRABODHINI - COLLEGE**

**Final Report**

**BIOME Environmental Trust Limited**

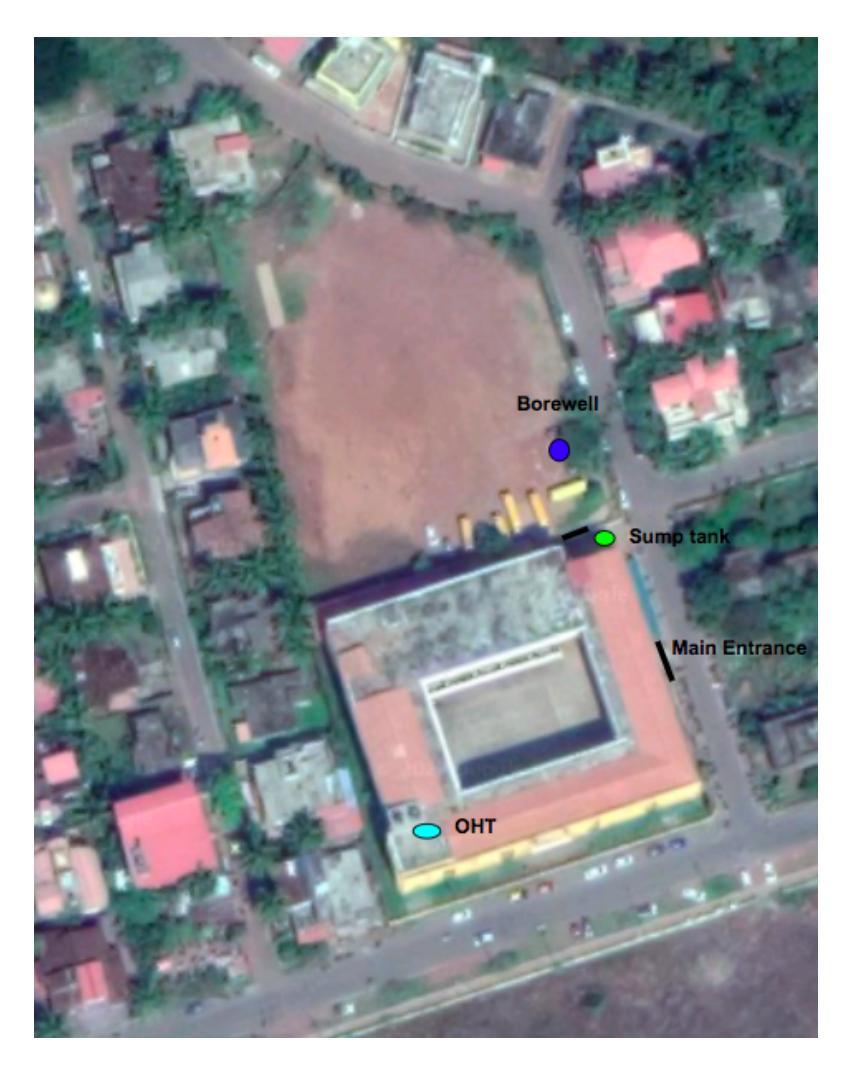
Fig 3: Overview and locations of key elements in the collage

The main source of water for the college is a borewell located in the playground. The institution also has municipal water supply connections.

Water from the borewell is pumped into a 60,000L sump located at the entrance of the playground. Water from this sump is pumped into the two overhead tanks of 10,000L capacity each. From here, water is then passed through Aquaguard filters for drinking purposes.

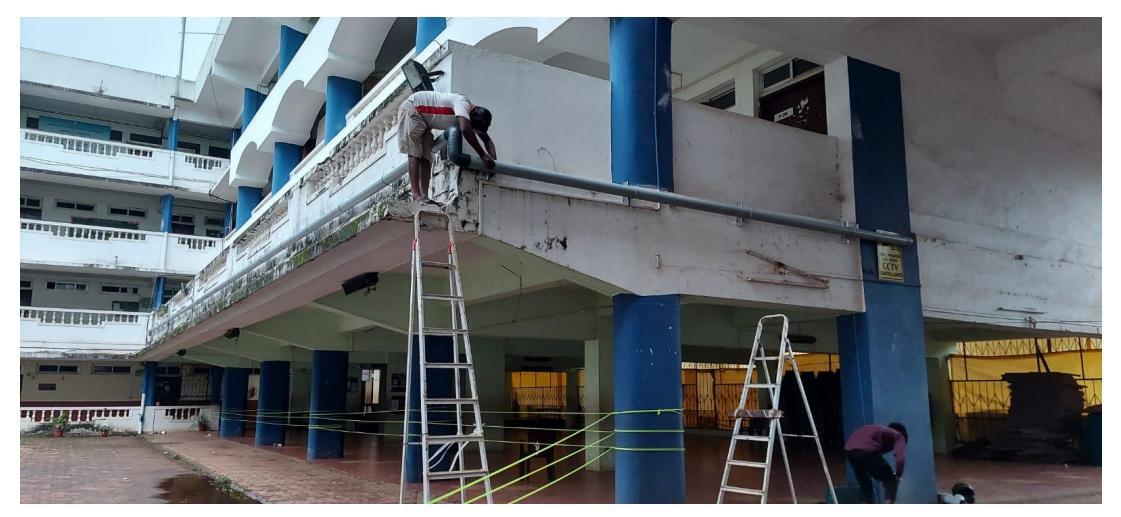
Fig 4: Installation of the plumbing system for rooftop RWH

**Plumbing:** Water from the 1221 sqm rooftop area is directed downwards through a system of downtake pipes. These are fitted with rainy filters (<u>https://www.rainyfilters.com/</u>) that help filter whatever dust is present in the water.

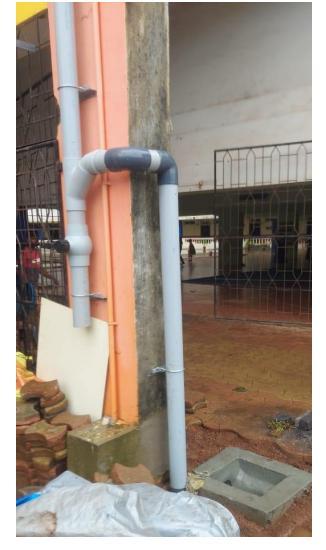
Fig 5: Fist rain separator

As a part of this system, first rain separators have also been installed to remove the first few minutes of the rain that might carry more dust/leaves/dirt from the rooftop.

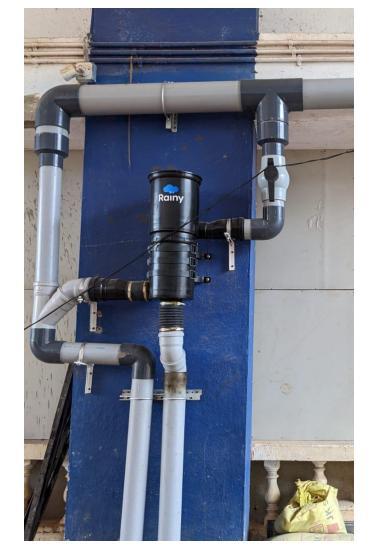
Fig 6: Rainy filter

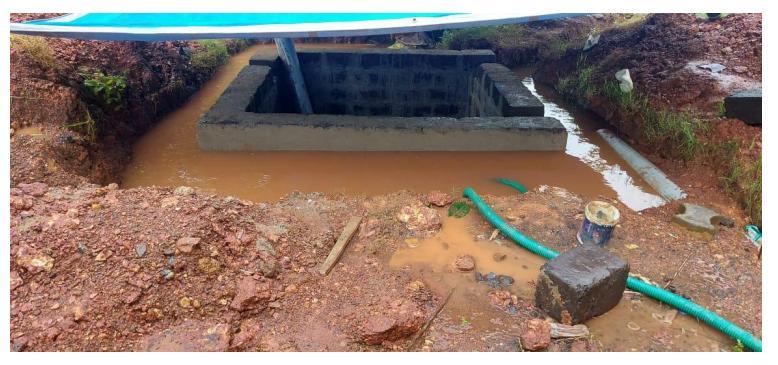
Fig 7: New sump during constriction

**New Rainwater Sump:** A new sump of 3KL capacity (6ftx6ftx3ft) serves as a rainwater storage tank before overflowing into the existing sump or the recharge well.

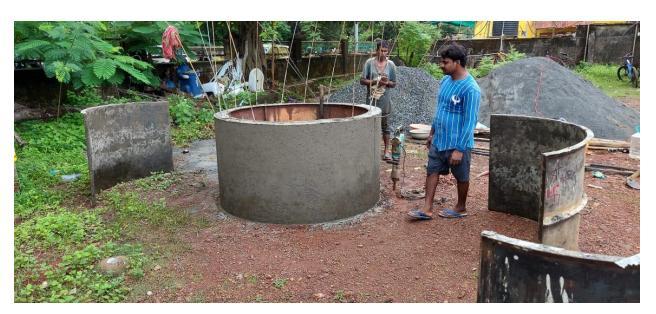
Fig 8: Recharge well ducting construction

**Recharge well:** Water from the rainwater sump overflows into a recharge well. The static volume of this recharge well is 13KL and is 5 feet in diameter and 24 feet deep.

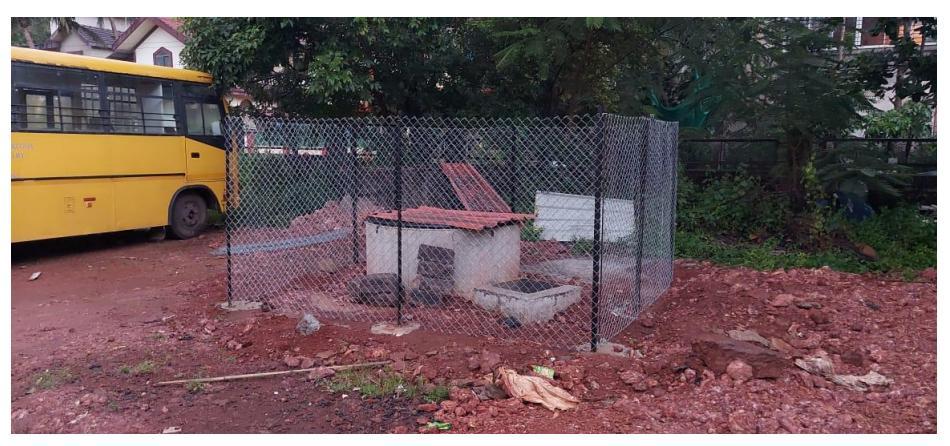
Fig 9: Recharge well protected by safety grill

Valves have been fitted to control the flow of water between the two sumps and also to the recharge well. The recharge well has also been covered by a grill at the top of the well. Also, a grill has been installed around the recharge well to ensure safety.

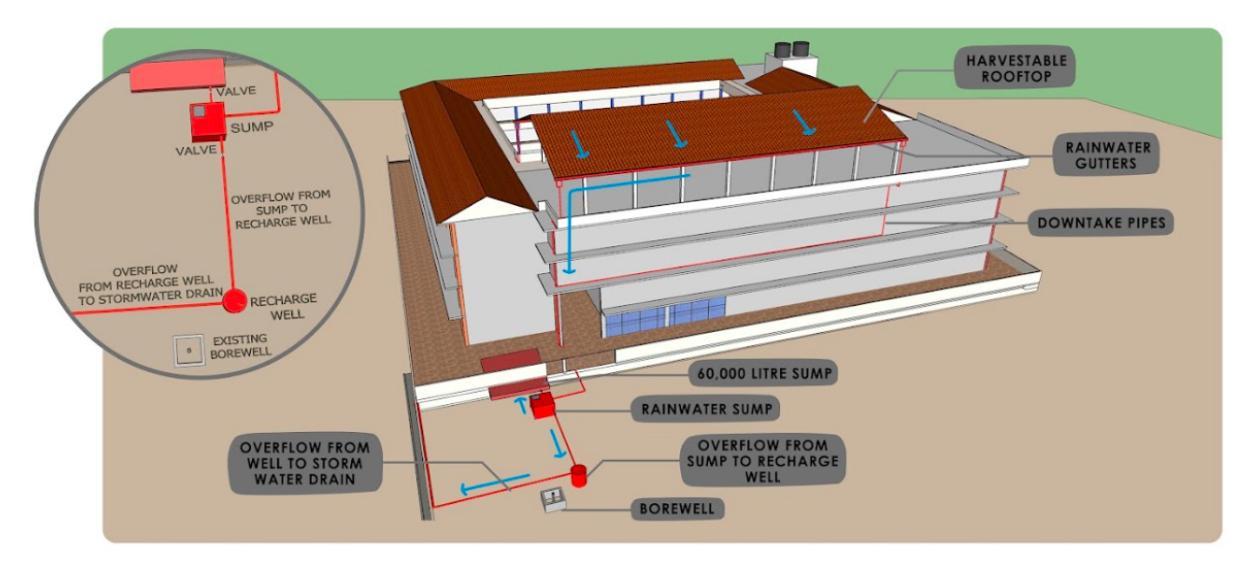
Fig 10: Schematic of the RWH system in the college

To enable rooftop rainwater harvesting, a new storage sump and a recharge well that can take overflows were considered on the college premises. The design and the flow of water through the system are explained in detail below.

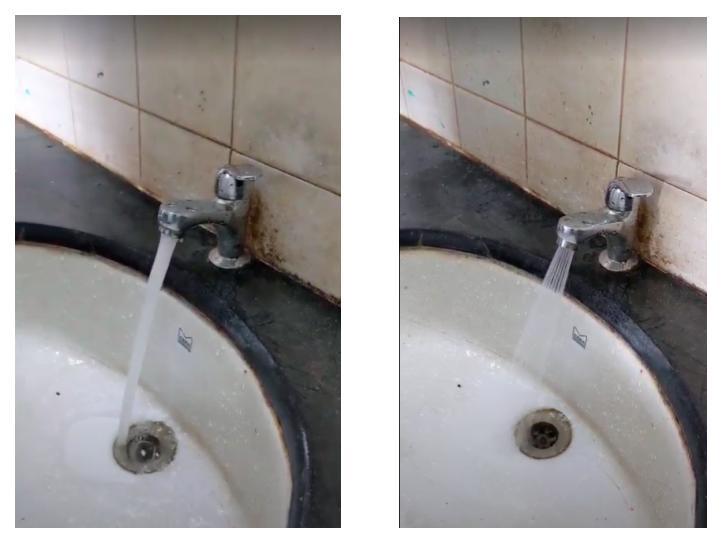
Fig 11: Water flow before(left) & after(right) fixing aerators

Along with rainwater harvesting, it was also necessary to conserve water and manage its demand. For this, 3LPM spray-type aerators are installed for hand wash taps in the toilets. This helps reduce total water wastage by two-thirds.

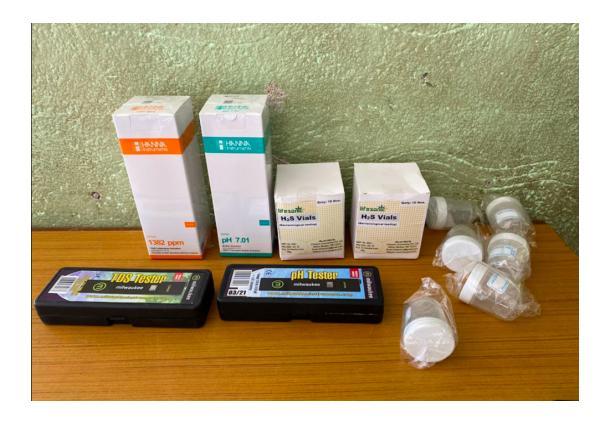
Fig 13: Water testing kit handed over to the institute

One pH meter, one TDS meter, calibration solutions for both, and H2S vials were handed over to the institution for regular use.

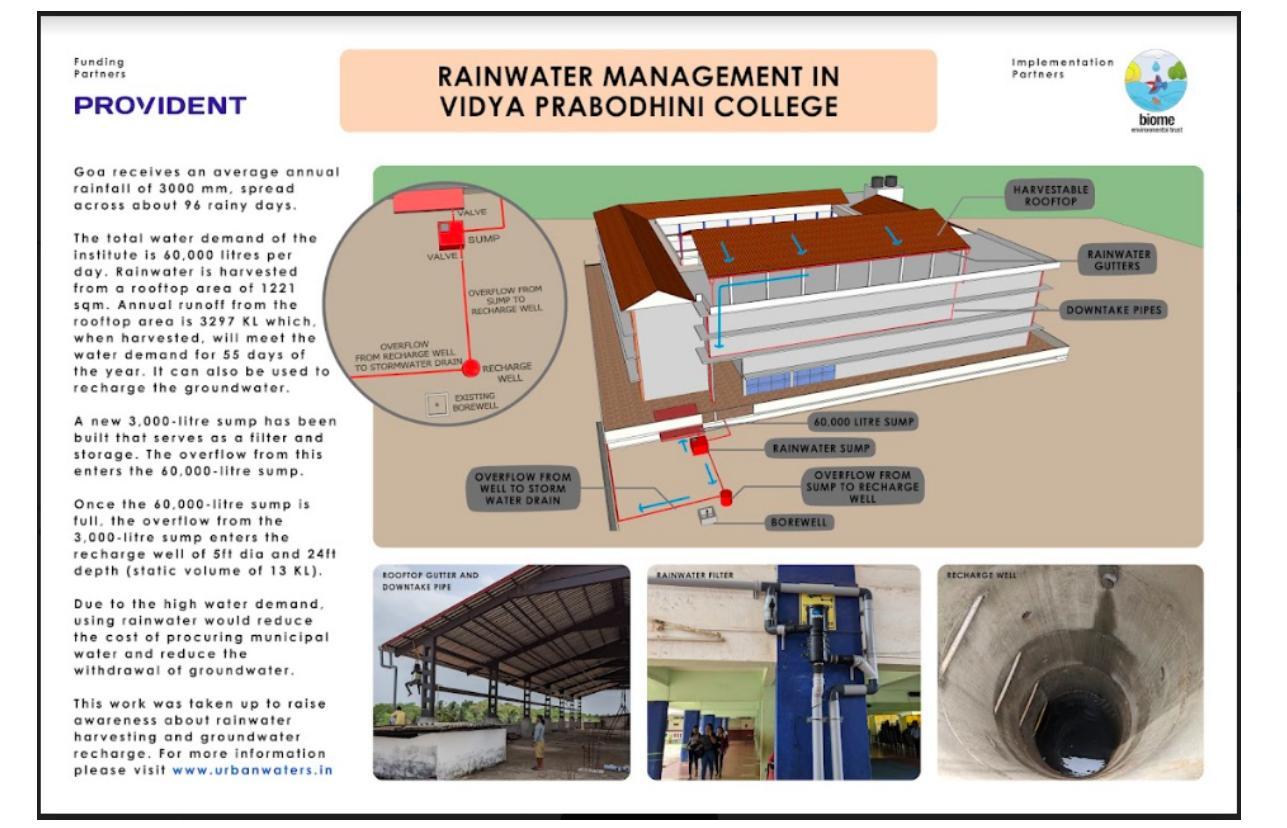
Fig 16: Contents of the communication board

The necessity of a board as a communication medium to demarcate the essential elements of the system was also felt. This would help people understand at leisure as well as help raise awareness. The board is installed near the recharge well.
